A Comparative Study of Inspection Techniques for Array Packages

Jelila Mohammed
Christopher Green
NASA Electronic Parts and Packaging (NEPP)

April 28, 2008

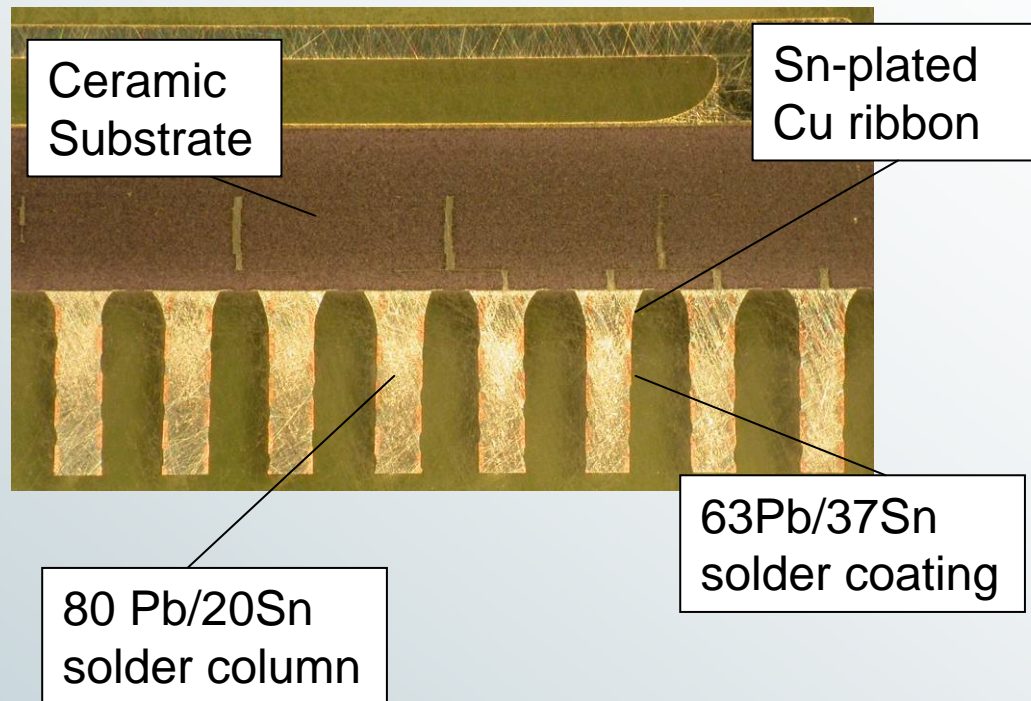
Test Device – Reinforced Column

- Daisy chained 484-pin CGA parts assembled onto test board
- Cu-reinforced columns
- Board was thermally and mechanically stressed

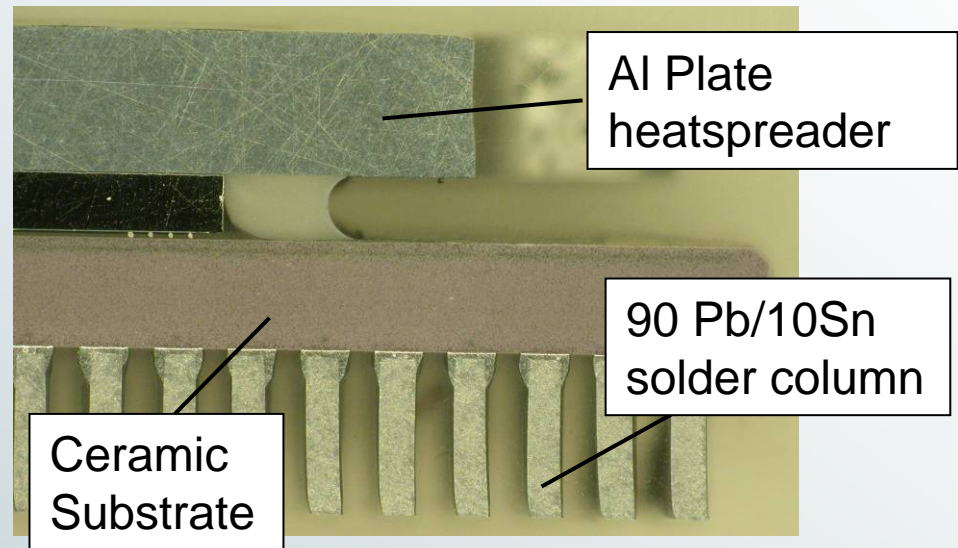
Test Device – Straight Column

- Daisy chained 1144-pin CGA parts assembled onto 2 test boards
- Workmanship defects were designed in during layout and assembly
- Board was thermal cycled
